**Results of Round Three
BMP Implementation Monitoring**

Oklahoma Department of Agriculture, Food and Forestry
Forestry Services Division

Implementation of Forestry Best Management Practices in Eastern Oklahoma

Results of 2007-2010 BMP Implementation Monitoring

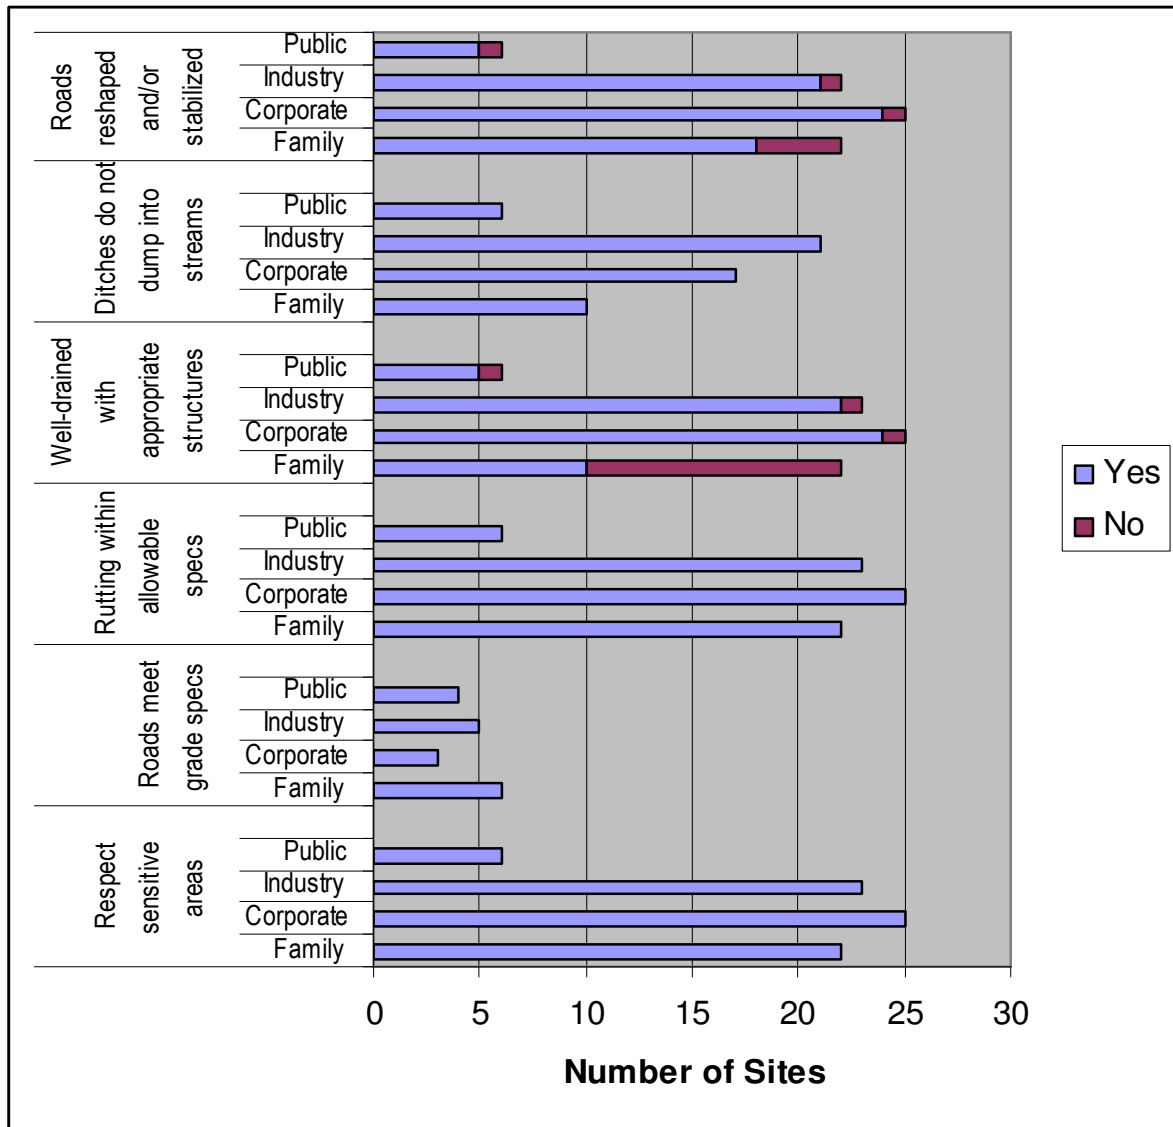
Figure 2. BMP Implementation on Permanent Roads by Ownership Category

Permanent road evaluation was applicable on 76 of the 100 sites. Overall implementation for permanent roads was 94.1% with no significant risks identified. The areas with the highest level of implementation (100%) in this category were with respect to sensitive areas, new or reworked roads meeting grade specifications, rutting within allowable specifications and ditches not dumping into streams. The lowest implementation rates were for roads not being well-drained with appropriate structures (80%) and roads not being reshaped and/or stabilized (91%). Each of these “low” ratings represents an improvement from the previous monitoring period. Those ratings were 77% and 79% respectively. In nearly every case, landowners made plans to repair their roads as a result of this evaluation and contact.

Actual implementation data is shown in Table 3. Figure 2 illustrates the rate of BMP implementation in each category of permanent roads by type of ownership. This format provides a readily visible view of the practices and ownership categories where BMP implementation needs improvement.

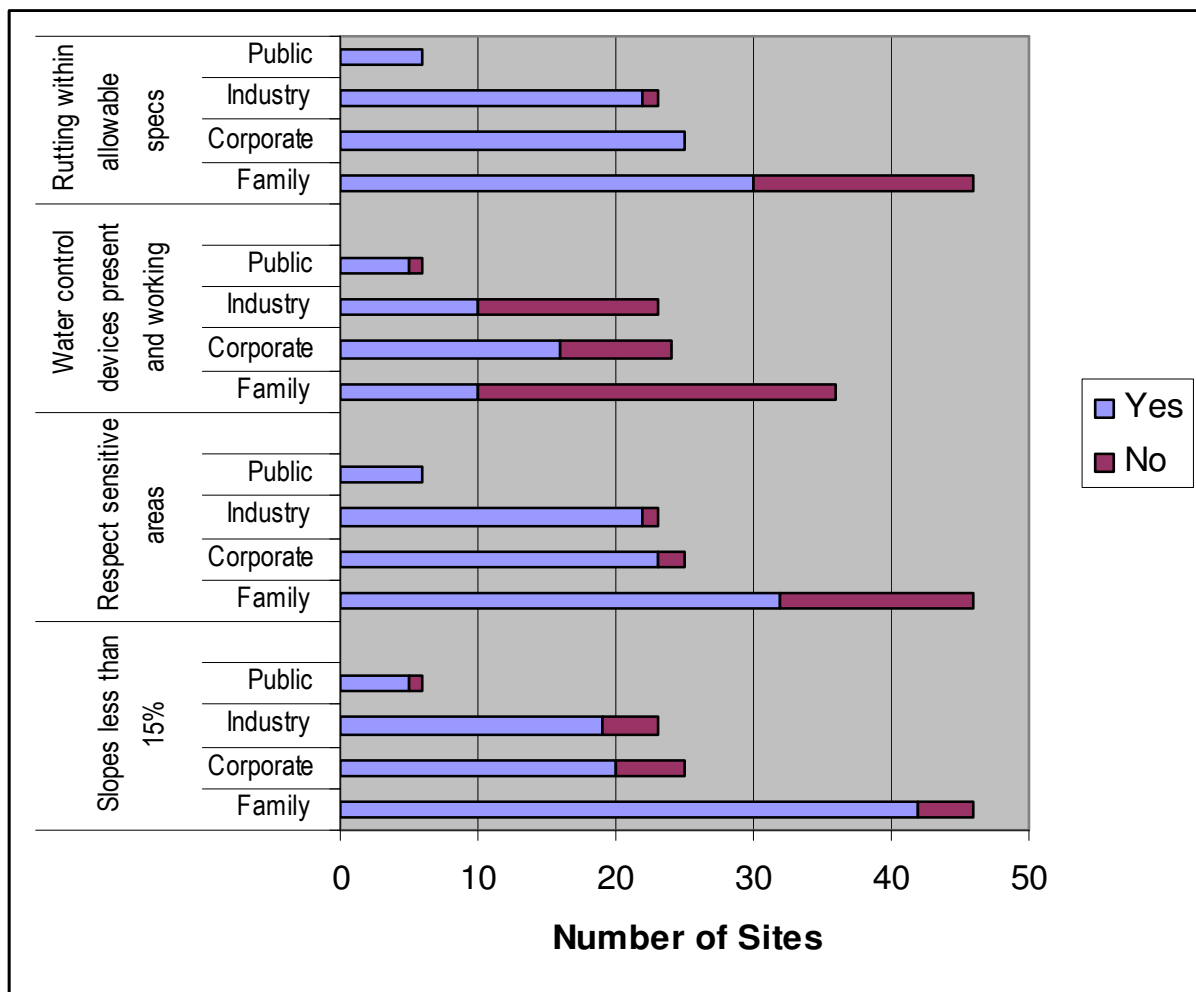
Figure 3. BMP Implementation on Skid Trails and Temporary Roads by Ownership Category

Skid trails and temporary roads were evaluated on all 100 sites. Skid trails are routes through the logging area by which logs are skidded or dragged to a permanent road or central loading point. Temporary roads are not designed to carry traffic long-term and are usually closed or reforested after the harvest activity. Implementation for skid trails and temporary roads overall was 75.3% and no significant risks were noted. The lowest implementation rate (46%) was for not having water control devices present and working. The three remaining practices all scored in the mid-eighties. Data is presented in Table 4 and Figure 3.

It is important to note that in areas where water control devices were recommended, the landowners have made restoration plans.

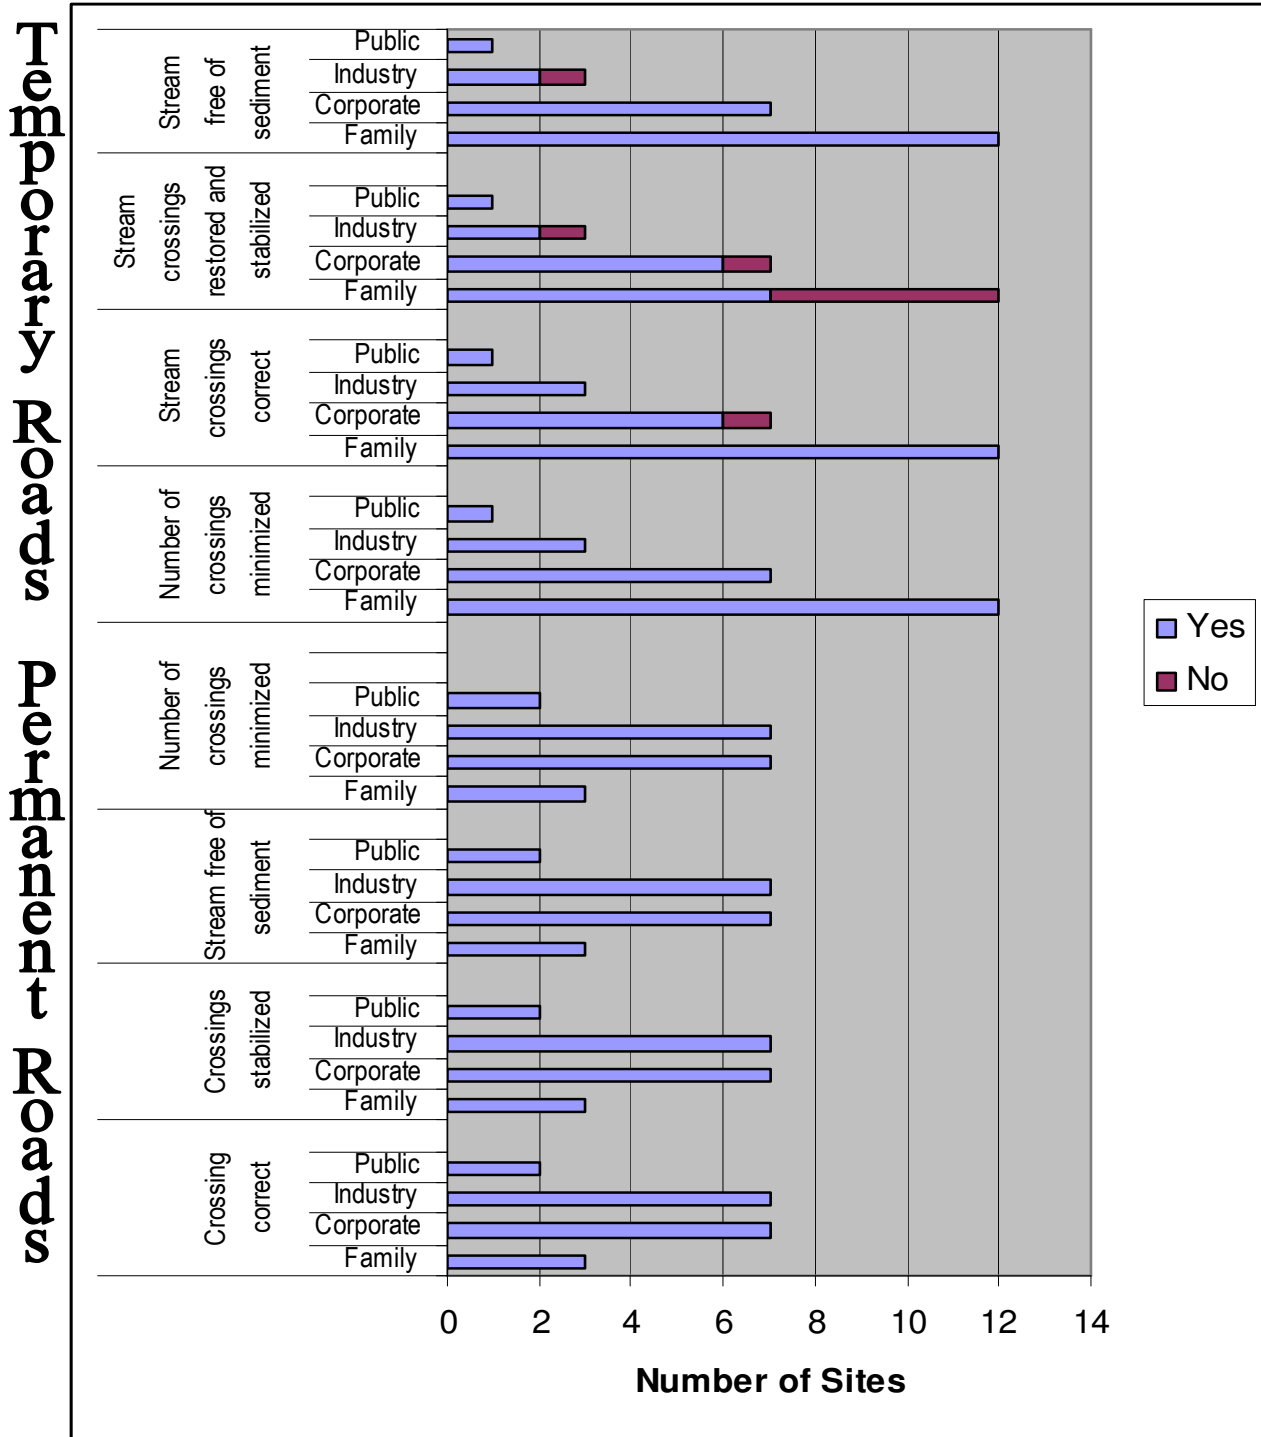
Figure 4. Road BMP Implementation on Stream Crossings by Ownership Category

Stream crossings were evaluated on 42 sites, and the data is presented in Table 5 and Figure 4. Nineteen sites had crossings on permanent roads only and 23 sites had crossings on temporary roads only. Eight sites had crossings on both permanent and temporary roads. On permanent roads, the overall implementation rate for stream crossings was 100% with no significant risks noted. All categories rated an implementation rate of 100%. This seems to indicate continued recognition by landowners and contractors the importance of protecting water quality and maintaining the permanent road system.

On temporary roads, the highest implementation rate was the number of crossings being minimized (100%). The lowest rating for temporary roads was for crossings not being restored and stabilized (70%). This practice also resulted in identification of four significant risks, the only ones noted in the entire monitoring project. Even though the number of sites with temporary stream crossings was few, these practices still need follow-up attention. Remediation of the four significant risks has been accomplished. In all cases, landowners received our recommendations for restoration very favorably.

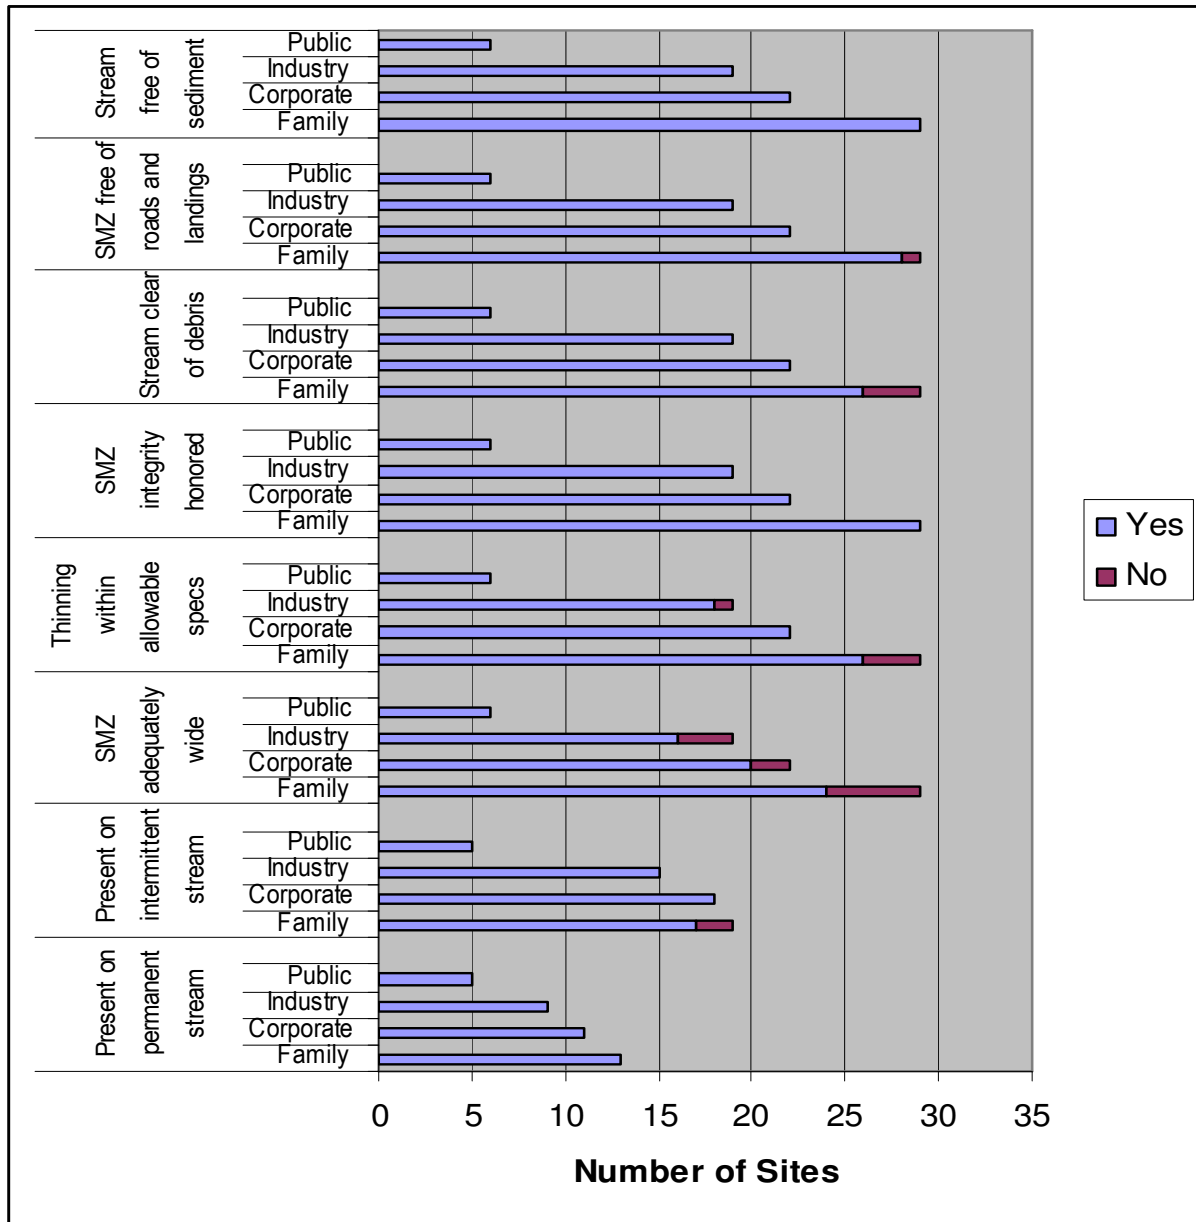
Figure 5. BMP Implementation on Streamside Management Zones by Ownership Category

Oklahoma’s BMPs recommend retaining a Streamside Management Zone (SMZ) of at least fifty feet on either side of all perennial and intermittent streams, lakes, ponds and reservoirs. All sites with either perennial or intermittent streams were evaluated for the presence and adequacy of SMZs. Streams were present on 76 of the 100 sites. Eighteen of the 76 sites contained perennial streams only, 40 had intermittent streams only and 18 sites contained both perennial and intermittent streams. SMZ data is presented in Table 6 and Figure 5.

The highest implementation rate (100%) was on four practices: SMZ presence on all perennial streams, integrity of the SMZ honored and streams free of sediment. The lowest implementation rate (87%) was the SMZ not being adequately wide.

Overall implementation of SMZ BMPs was 96.4% with no significant risks. It is noteworthy that this category has a high BMP implementation rate with no significant risks, an indication that landowners and contractors generally respect the importance of streamside management zones and their role in water quality protection.

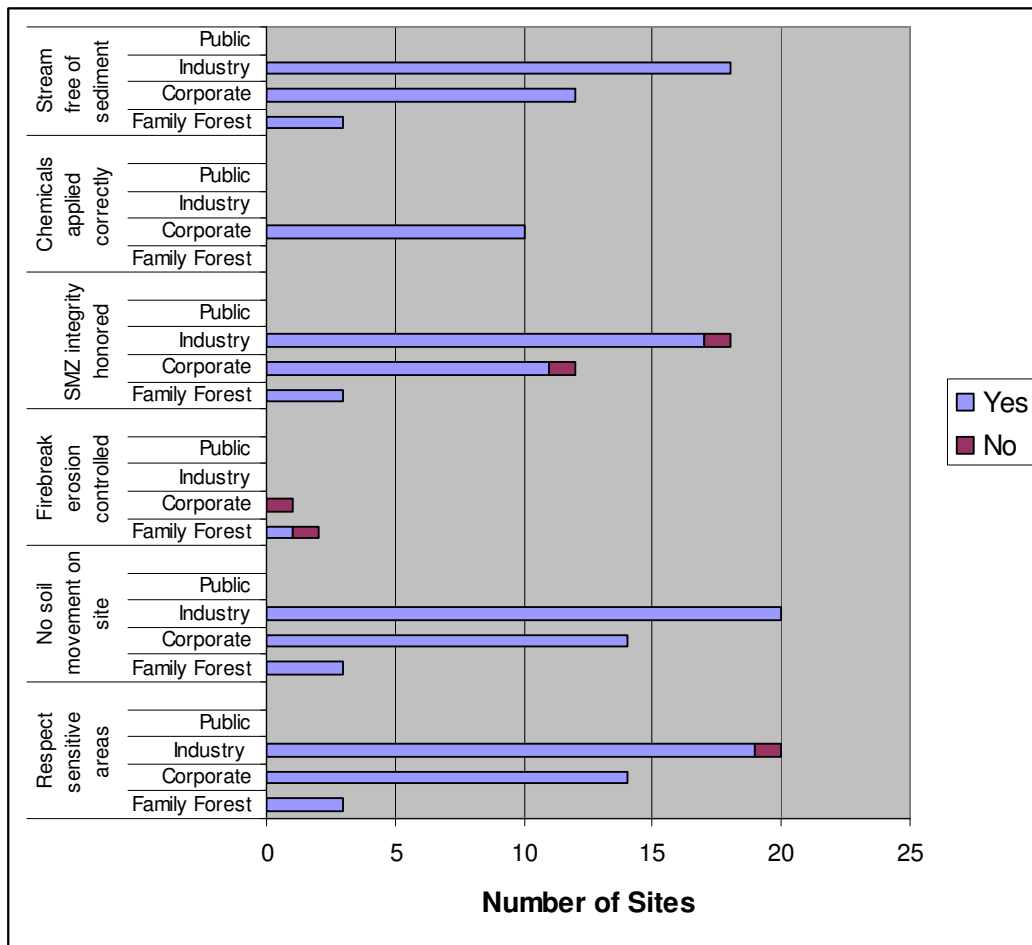
Figure 6. BMP Implementation Related to Site Preparation by Ownership Category

Site preparation consists of work done to prepare a site for the growing of trees, generally to plant seedlings. Thirty-seven sites were evaluated for implementation of site preparation BMPs. A variety of site preparation techniques were evaluated, including ripping, burning, drum chopping, shearing, piling, injecting and spraying, sometimes used in combination. The data is presented in Table 7 and Figure 6. The overall implementation rate for site preparation was 96.7% for this evaluation period, compared to 90% in the previous survey. The lowest implementation rate (33%) was for not having erosion properly controlled on the firebreak, although only three sites were evaluated for this practice. The highest implementation rates

(100%) were for no soil movement, chemicals being applied correctly and streams free of sediment. The implementation rate for respecting sensitive areas was 97%.

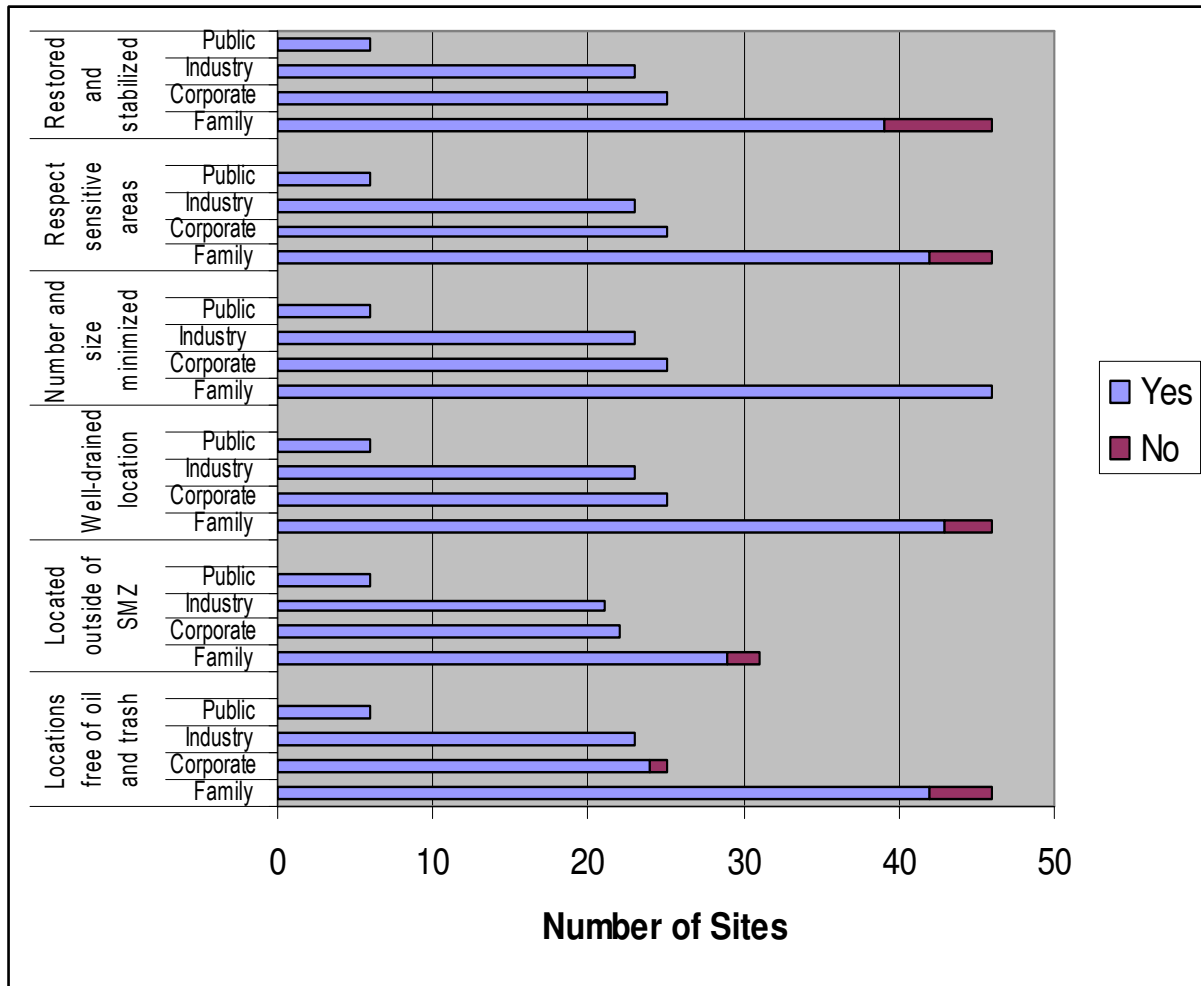
Figure 7. BMP Implementation Related to Landings by Ownership Category

Landings are areas where logs are gathered, delimbed, bucked (cut-to-length for certain products and/or removing the top) and loaded onto trucks. Landings were evaluated on all 100 sites with an overall implementation rate of 96.4% and no significant risks were noted. The highest implementation rate (100%) was for the number and size of landings being minimized. The lowest implementation rate (93%) was for landings restored and stabilized. Owners of landings where problems were identified have already planned remediation activities. Data is presented in Table 8 and Figure 7.

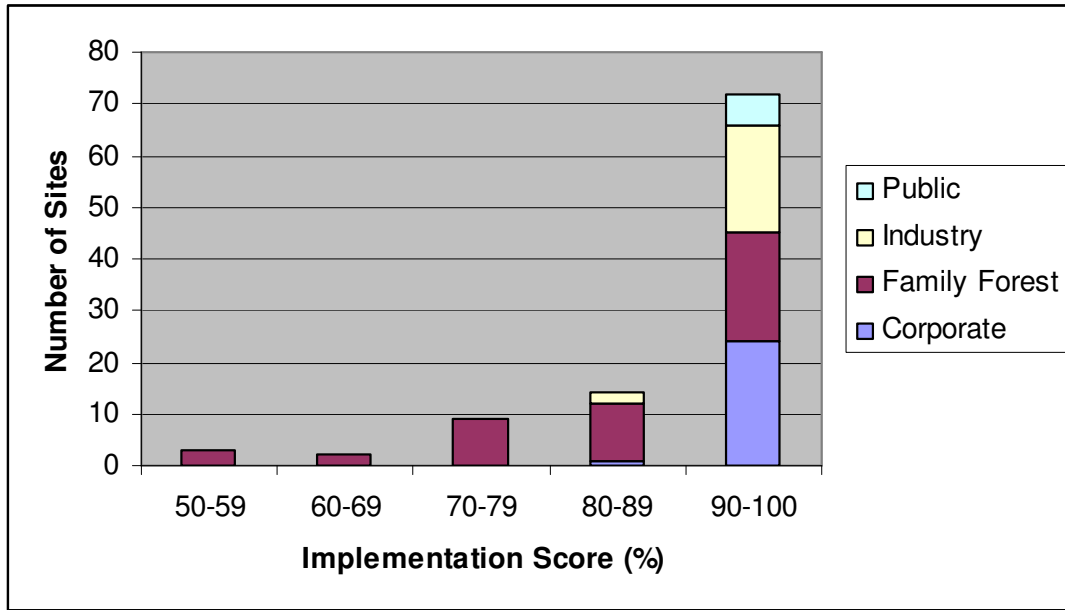
Figure 8. Overall BMP Implementation Score by Number of Sites and Type of Ownership

To illustrate the spread of the implementation scores, Figure 8 separates the results into five categories: 50-59%, 60-69%, 70-79%, 80-89% and 90-100%. This provides the number of tracts across all ownership types receiving the respective level of overall BMP implementation.
